TECH BULLETIN: SPITFIRE VALVE INSTALLATION ISSUES

Parts Affected: All assemblies, kits, or part orders containing Capstan Spitfire Valves

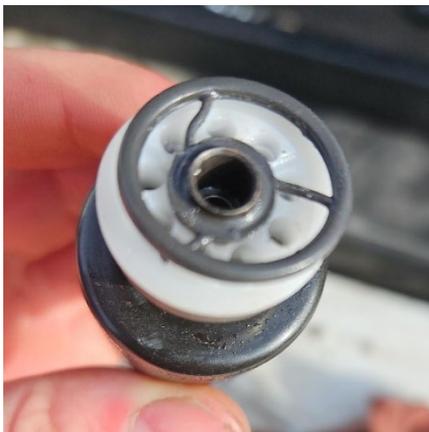
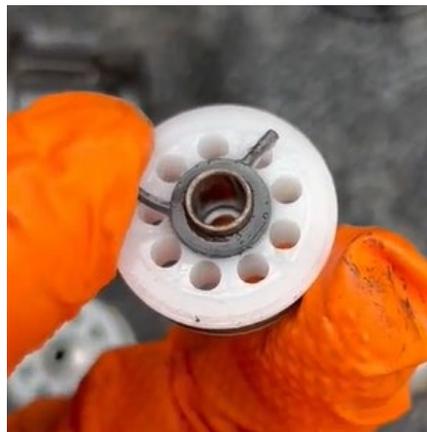
- 1.1. Improper Installation can result in torn or twisted O-rings and will result in leaks.
 - 1.1.1. SpitFire coils **MUST NOT** be rotated upon installation. This will distort/damage the O-ring.
 - 1.1.2. Hold the coil firmly while only rotating the flynut to tighten the valve.

*O-RINGS DAMAGED FROM IMPROPER INSTALLATION
WILL APPEAR TORN OR DEFORMED*

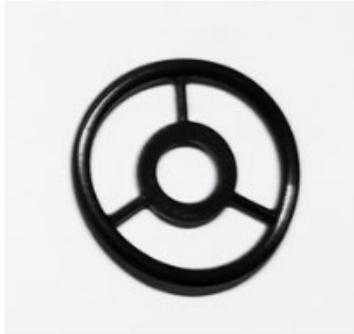
2.1. O-rings that are misshapen or otherwise not fully round prior to installation are more likely to result in installation difficulties that may result in leaks.

✗ *NEEDS REPLACEMENT*

OUT-OF-ROUND

2.2. Inspect parts before installation to ensure the O-rings have arrived undamaged.

2.3. Capstan Ag will supply new O-rings at no cost to the customer to replace any out-of-round O-rings found prior to initial installation.

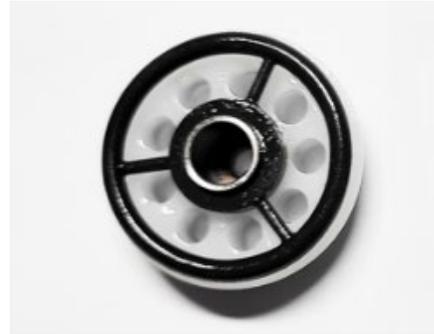
✓ *WORKING CONDITION*

ROUND AND CONNECTED
