Service Bulletin

CapstanAG Valve Service Procedure

The new valve design requires new service details.

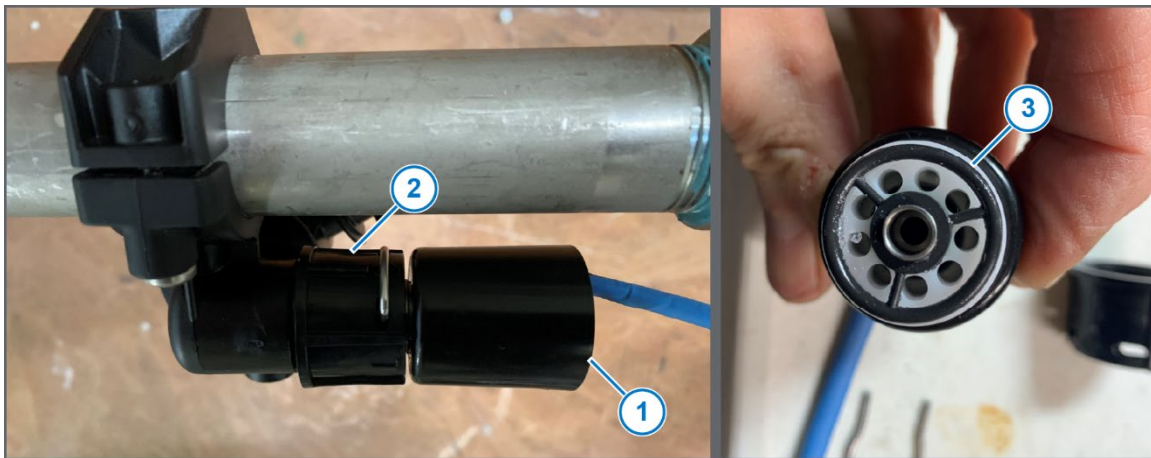
Figure 1

Figure 1: Hold the coil (1) stationary while tightening the flynut (2). If the coil is rotated while tightening the flynut, damage to the spoke O-ring (3) can occur and cause the valve to leak.

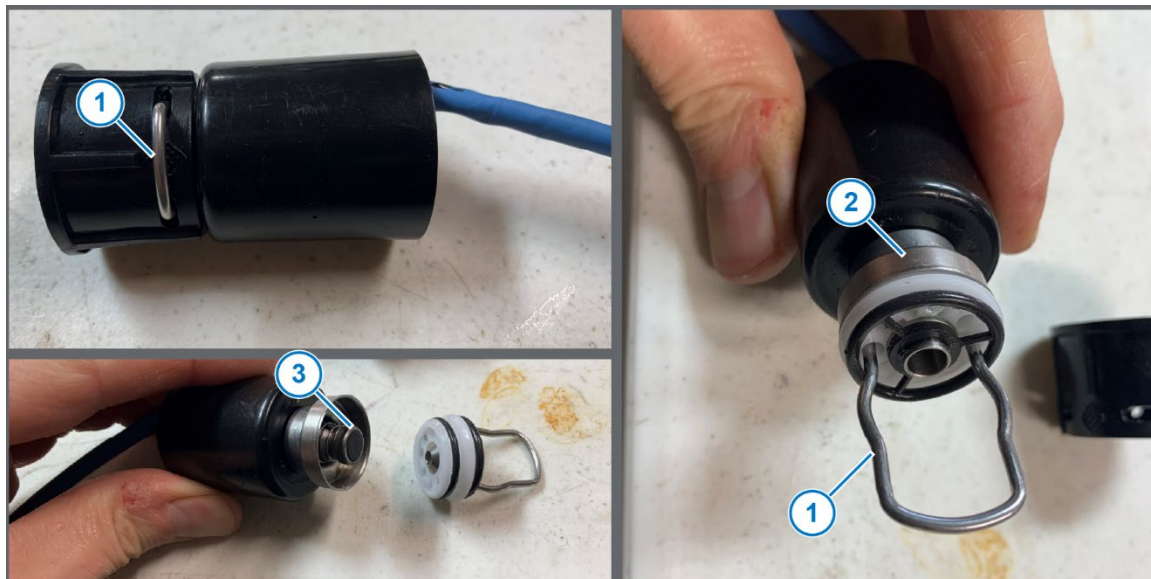
Figure 2

Figure 2: To service the valve components, remove the retaining clip (1). Use the retaining clip to remove the orifice insert (2) to service the plunger (3).
